CODING OF 406 MHz SATELLITE EPIRBs

406 MHz EPIRB coding

Note by the United States

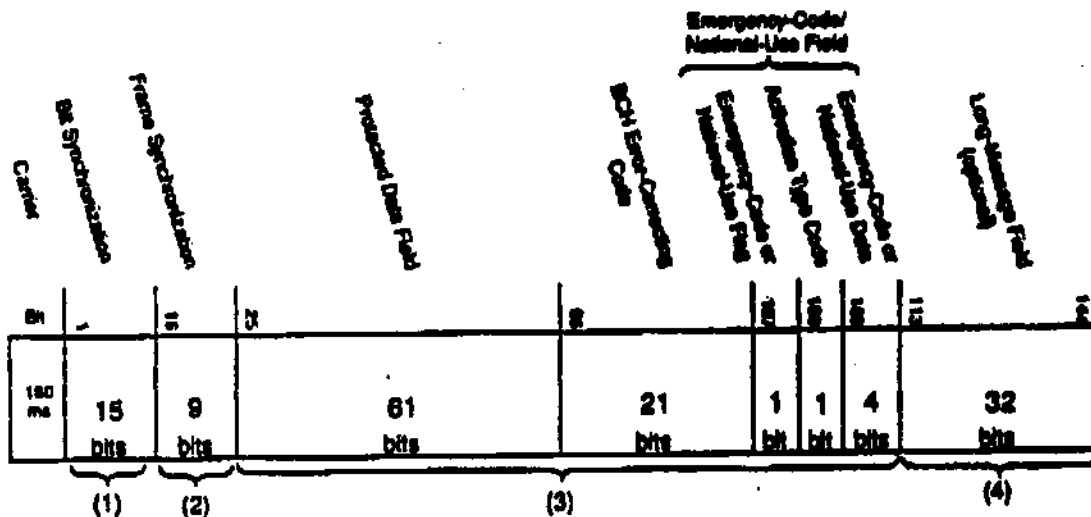
FIGURE 1
 GENERAL 406 MHz MESSAGE FORMAT

1 This paper discusses a potential danger in interpretation of the 406 MHz satellite EPIRB digital message, Activation Code (bit 108). See Figure (1), Beacon Coding Scheme.

2 Bit 108 was originally intended to indicate whether the beacon was manually or automatically activated (i.e., bit 108 = 0, beacon was manually activated; bit 108 = 1, beacon was automatically activated). It was originally envisioned that the beacon would have the capability to automatically change this bit coding depending upon the actual method of activation. Most manufacturers felt meeting that requirement was not feasible. COSPAS-SARSAT evaluated this concern, and revised the definition of bit 108; i.e., bit 108 = 1 for beacons that can be activated both manually and automatically. Because of some confusion and inconsistency in the early generation of beacons on the coding of this bit, some beacon manufacturers assigned bit 108 = 0 for some beacons that can also be automatically activated.

5 National SAR authorities should realize that the beacon Activation Code entry has no guaranteed meaning, and EPIRB approving authorities should investigate the practices of their manufacturers.
