Appendix E – Marine Casualty Analysis

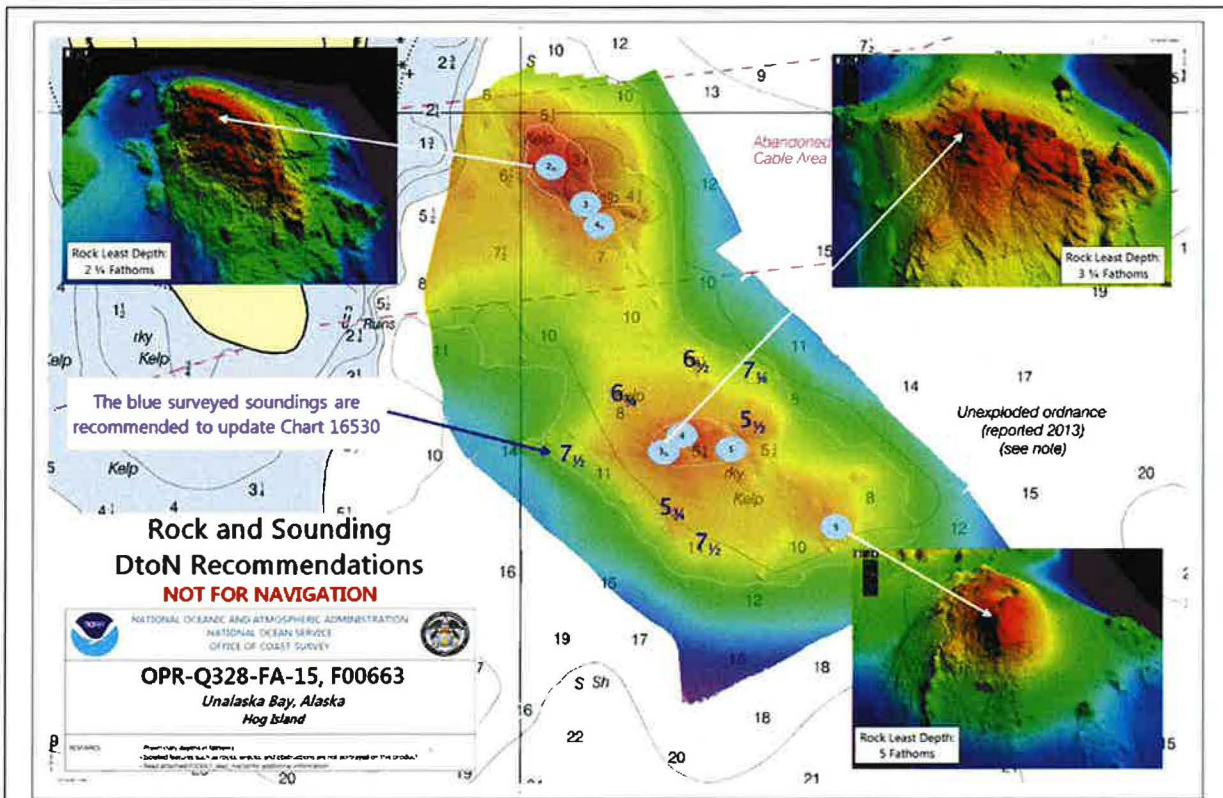
Grounding #1 (Casualty # 132): In July of 2015, a 9,300 gross ton research vessel with a draft of 27 feet struck an incorrectly charted area of shoal water near Dutch Harbor, Alaska, sustaining a hull fracture approximately 39 inches long and two inches wide. No injuries or pollution was associated with this accident. The vessel had just begun a voyage from Dutch Harbor, AK intending to transit the Bering Strait and continue on to the Chukchi Sea to participate in Outer Continental Shelf (OCS) exploratory drilling. The hydrographic survey information in the area of the grounding dated back to 1935. A NOAA Coast Survey ship was able to investigate immediately. While the chart showed shoal water with a least depth of 5 ¼ fathoms, or 31.5 feet, the actual depth was determined to be as little as 3 ¾ fathoms, or 22.5 feet.

Figure 13: Example of modern multi-beam survey report finding previously uncharted dangers to navigation.
