SN/Circ.210 10 March 2000

INFORMATION ON RELOCATION OF TWO NAVIGATIONAL BUOYS IN THE TRAFFIC SEPARATION SCHEME "SOUTH OF GEDSER"

RELOCATION OF NAVIGATIONAL BUOYS IN TRAFFIC SEPARATION SCHEME (TSS) "SOUTH OF GEDSER"

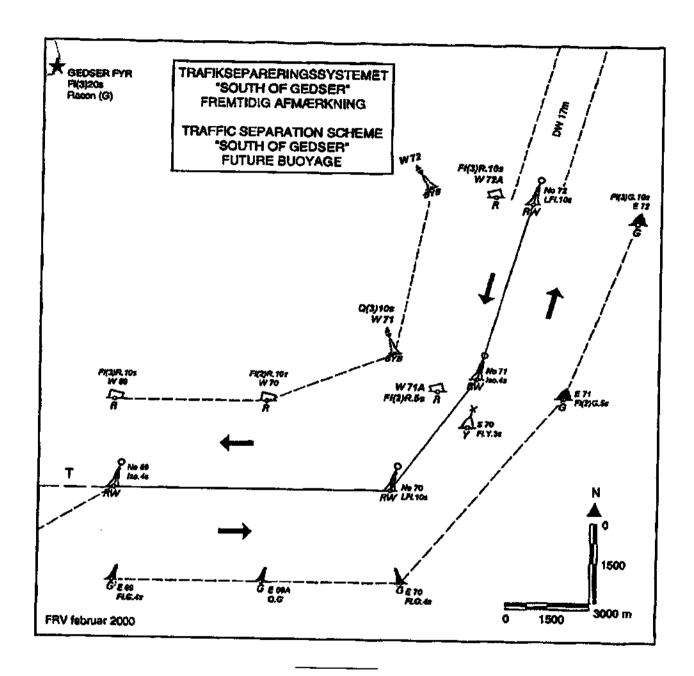
During the last couple of years 8 groundings have taken place in the southbound traffic lane in the area which lies SE of position 7 (re Ships' Routeing, Seventh Edition, 1999, B I/10). The depths in the area in question are between 10 and 13 metres and the grounding ships presumably all came from the Deep-Water (DW) route leading to the traffic separation scheme from the north.

- In order to solve this problem in a safe and quick manner, the Danish and German Authorities have decided to relocate the two red buoys placed in positions 6 and 7 (W72 and W 71) eastwards so that they mark the 17 metres depth curve. This solution is believed to prevent ships coming from the DW route to run aground in the above-mentioned area. Further it has been agreed to place an East Cardinal light buoy in each of the positions 6 and 7 in order to maintain the marking of the traffic lane. The traffic separation scheme will thus be maintained as described in Ships' Routeing Publication.
- The text of the navigational warning, which will be issued in Danish and German Notices to Mariners is reproduced below.

The sketch at annex depicts the above-mentioned changes.

- 1) 54° 31′.55 N. 12° 10′.63 E. (Pos.6, B I/10), Red light-buoy »W 72« (Fl(3)R.10s).
- 2) 54° 31′.30 N. 12° 12′.80 E.
- 3) 54° 27′.30 N. 12° 10′.90 E. Yellow light-buoy »S 71« (Fl(4)Y.10s).
- 4) 54° 28'.07 N. 12° 09'.41 E. (Pos.7, B I/10) Red light-buoy »W 71« (Fl(2)R.5s).
- a. The red light-buoy (Fl(3)R.10s) at position 1) will be moved to position 2) and named »W 72A«.
- b. The yellow light-buoy (Fl(4)Y.10s) at position 3) will be permanently withdrawn.
- c. The red light-buoy (Fl(2)R.5s) at position 4) will be moved to position 3) and named »W 71A«.
- d. At position 4) an E. cardinal pillar light-buoy (Q(3)10s), named »W 71«, will be established.
- e. At position 1) an E. cardinal pillar light-buoy (Q(3)10s), named »W 72«, will be established.

Note. Deep draught vessels are recommended to keep east of a straight line between positions 2) and 3).
