## DGPS SITE OPERATIONAL ASSESSMENT

**NDGPS Site:** *Cheboygan DGPS Site (836)*  
**Inspector(s):** LT Christian Hernaez, LT Michael Brashier  
**Date:** 27JUL12

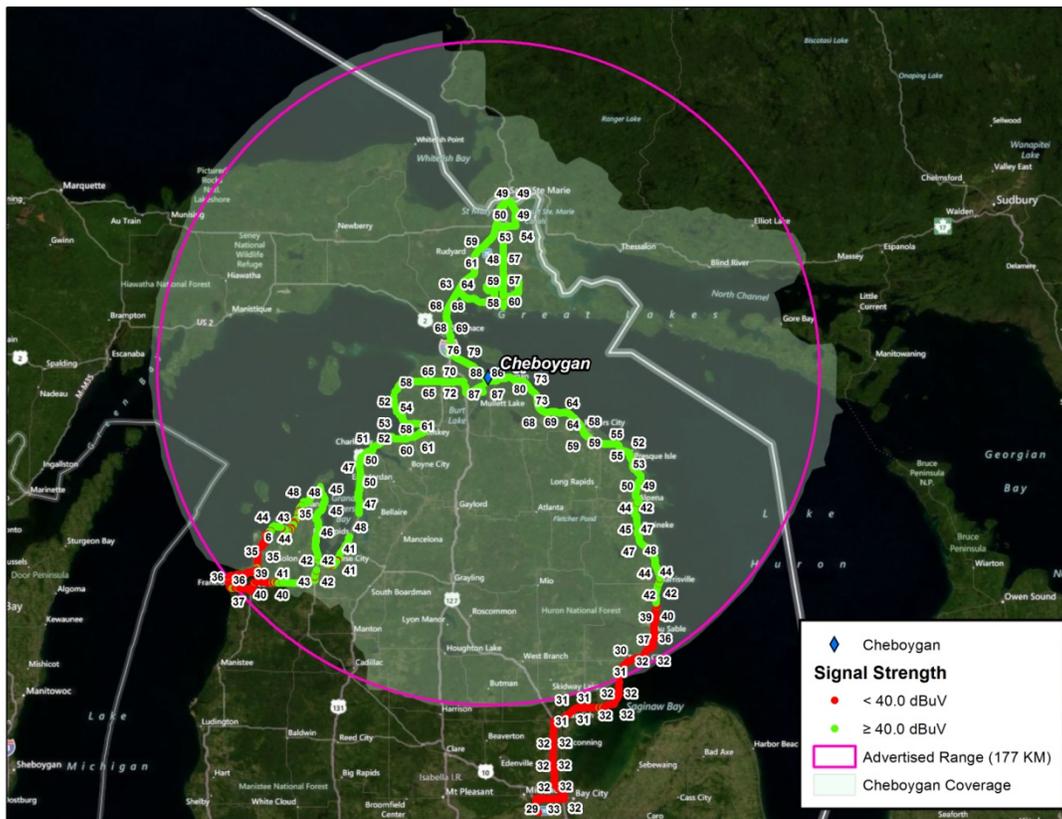
Figure 1: DNAV Signal Strength Results

A verification of the Cheboygan Differential GPS (DGPS) coverage area was conducted from Saginaw, MI, along the west coast of Lake Huron, through Cheboygan, along the east coast of Lake Michigan, to Manistee, MI. The advertised signal strength range is 177 km. Figure 1 below displays the recorded signal strength throughout the trip; the measurements were conducted with a STARLINK DNAV 212 DGPS receiver paired with a Trimble MBA-2 Antenna. Green points represent areas of satisfactory signal strength. Areas of unsatisfactory signal strength are represented with red points. Far-field (FF) signal strength readings were

taken at southwest and southeast points of the advertised range from both sides of the site with both the STARLINK DNAV 212 DGPS receiver and the Potomac Instruments 4100 FIM meter (Table 1 and Table 2). The signal strength readings taken at the FF points failed to meet the minimum 40 dB $\mu$ V/m for a site with a transmission baud rate of 200. Transmission output power and reflected power were confirmed with the NAVCEN DGPS watchstander to be at satisfactory levels. The local weather was mid-70's, partly cloudy, and was not a factor. The lack of signal strength may be due to the land over which the ground-wave must propagate. A decrease in the advertised range ring or increase in the operating power may be required. The vast majority of the signal strength readings along the coastline were well within the required signal strength minimum.

The Operational Assessment of the Cheboygan DGPS site revealed a slight inconsistency between the advertised range ring and the actual signal strength range. However, the majority of the coastal area is receiving satisfactory signal strength. Areas of the Cheboygan coverage area that did not meet the minimum signal strength levels have redundant coverage provided by the Sturgeon Bay DGPS site and the Detroit DGPS site. All RTCM messages were verified, evaluated, and are consistent with the requirements set forth by Reference (2) and (3). Finally, accuracy measurements and analysis proved that at a distance of approximately 75 km from the broadcast site, the horizontal accuracy is sub-meter and within the accuracy requirements set forth by Reference (1) and (2).
