DIFFERENTIAL GPS (DGPS) SITE OPERATIONAL ASSESSMENT

NDGPS Site: Whidbey Island, WA DGPS Site (888)
Inspector(s): LTJG Joe Kliman & CWO Wayne Horn
Date: August 2016

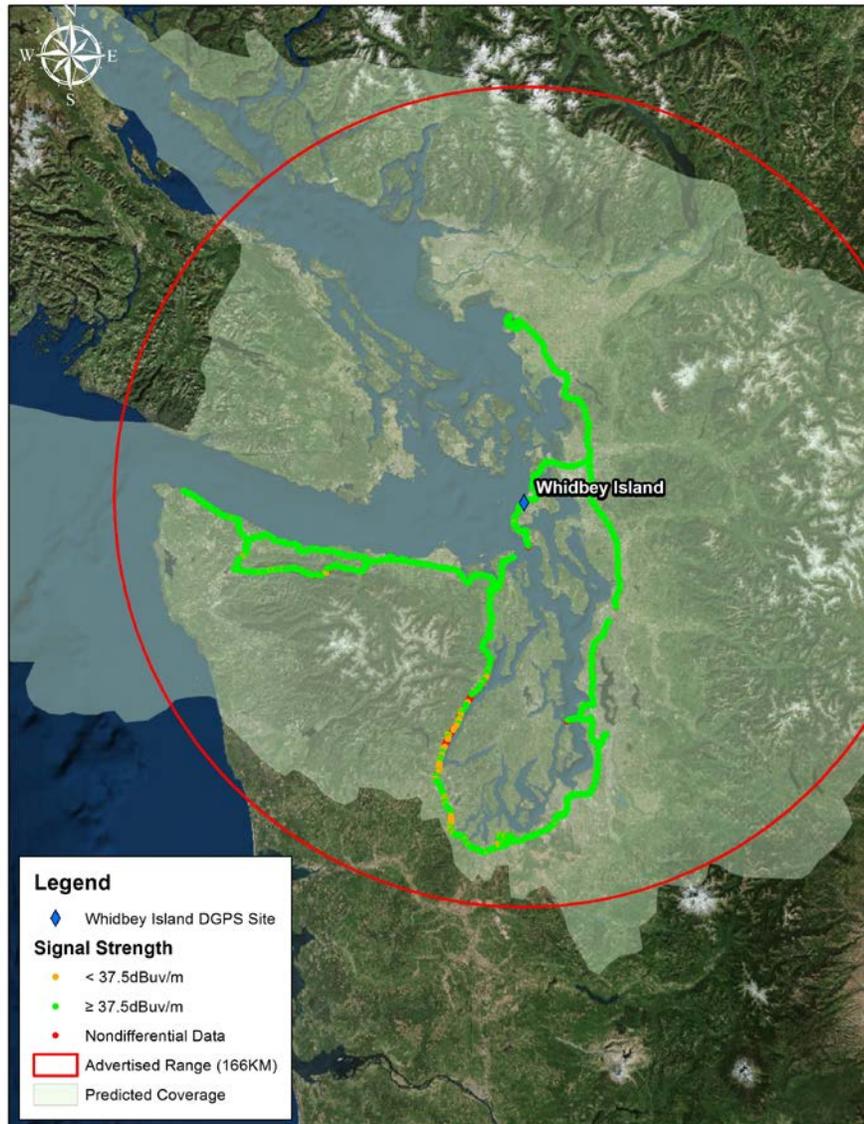
Figure 1: Signal Strength Results

A verification of the Whidbey Island DGPS coverage area was conducted via a circuitous route around Puget Sound. The advertised signal strength range is 166 km. Figure 1 below displays adequate signal strength on and around the Puget Sound, with terrestrial masking limiting the signal strength to the southwestern region of the route. Green points represent areas of signal strength above 37.5 dB μ V/m, whereas areas below 37.5 dB μ V/m are represented in yellow. Areas where a DGPS fix was unable to be obtained are represented in red. As seen in Table 1 and Table 2, far-field signal strength readings were taken at northern and western points of the advertised range from both sides of the site. Both northern and western far-field readings were above the required 37.5 dB μ V/m signal strength on both sides.
