## DIFFERENTIAL GPS (DGPS) SITE OPERATIONAL ASSESSMENT

**NDGPS Site:** Angleton, TX DGPS Site (828)  
**Inspector(s):** ENS Ryan Quarry & CWO Wayne Horn  
**Date:** July 2016

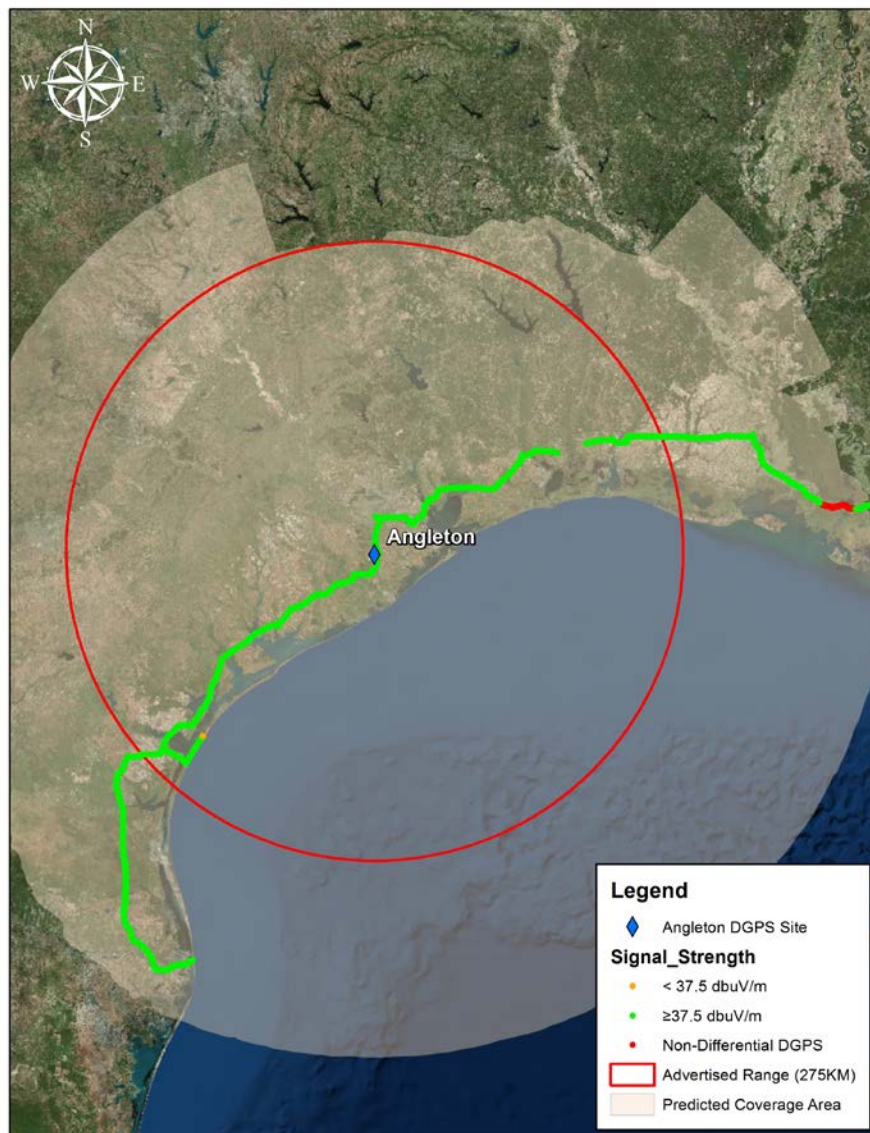
Figure 1: Signal Strength Results

A verification of the Angleton DGPS coverage area was conducted from New Orleans, LA, along the coast of the Gulf of Mexico, to Brownsville, TX. The advertised signal strength range is 275 km. Figure 1 below displays adequate signal strength, beyond the advertised range of 275 km from the site and throughout the predicted coverage area. Green points represent areas of signal strength above 37.5 dBμV/m, whereas areas below 37.5 dBμV/m are represented with yellow points. Areas where a DGPS fix was unable to be obtained are represented in red. The red area in the eastern portion of Figure 1 was while the team was traveling through a heavy industry area with many high-power overhead wires. The Signal to Noise Ratio on the receiver dramatically dropped/raised when entering/exiting the area. As seen in Table 1 and Table 2, far-field signal strength readings were taken at eastern and western points outside of the advertised range from both sides of the site. Both eastern and western far-field readings were above the required 37.5 dBμV/m signal strength on both sides.
