DIFFERENTIAL GPS (DGPS) SITE OPERATIONAL ASSESSMENT

NDGPS Site:	Point Loma DGPS Site (881)
Inspector(s):	LT Hermie Mendoza, CWO Louie Baytan
Date:	28 Jul 2013

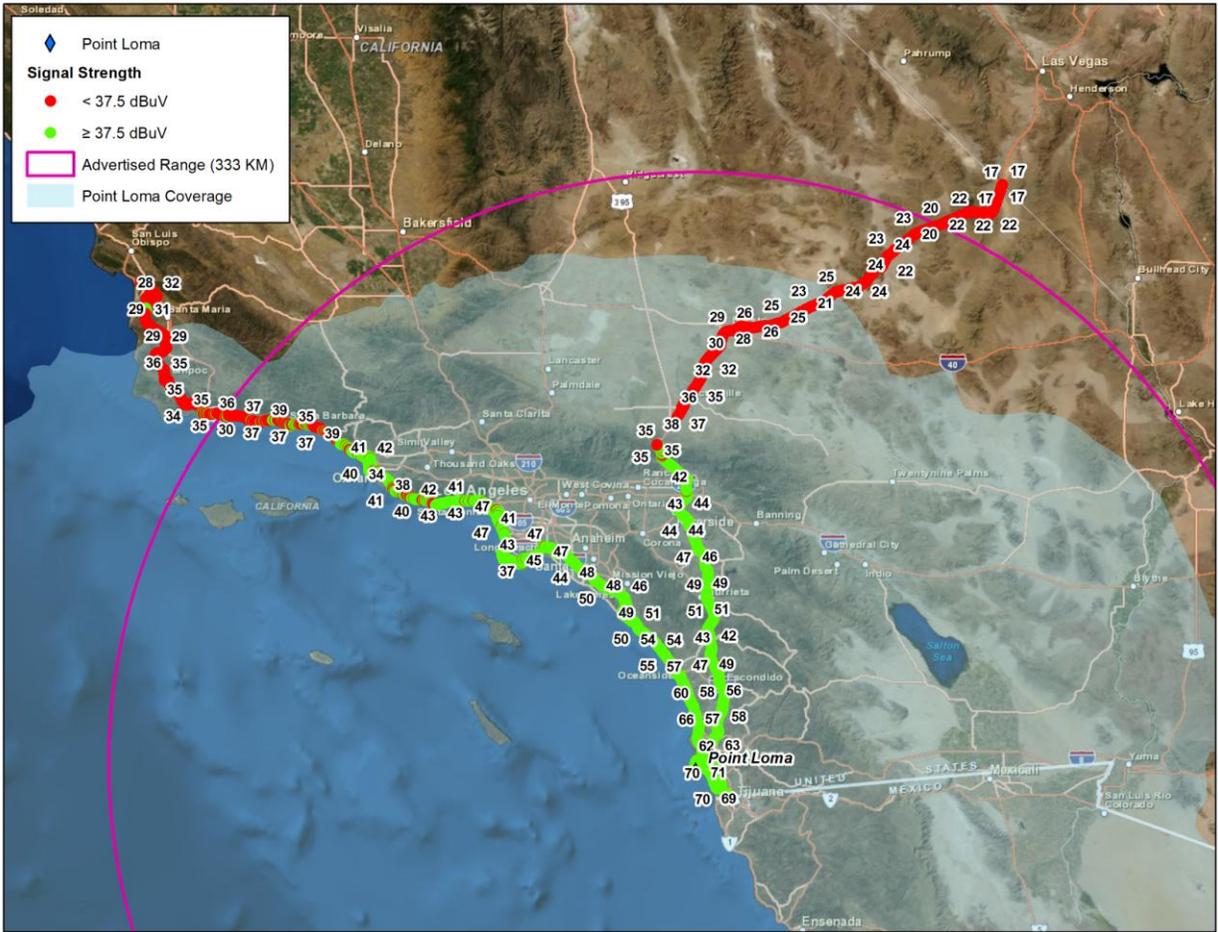
Figure 1: DNAV Signal Strength Results

A verification of the Point Loma DGPS coverage area was conducted from Santa Maria, CA along the Pacific Coast to San Ysidro, CA. The advertised signal strength range is 333 km. Figure 1 displays inadequate signal strength to the advertised range of 333 km from the site. Green points represent areas of satisfactory signal strength. Areas of unsatisfactory signal strength are represented with red points. Far-field (FF) signal strength readings were taken at northern point of the advertised range from both sides of the site (Table 1 and Table 2). The northern FF readings were below the required 37.5 dB μ V/m signal strength.

The Operational Assessment of the Point Loma DGPS site revealed that the provided coverage is not consistent with the predicted coverage plot and advertised range. Both northern and northeastern Far-Field signal strength readings were below the required signal strength. The signal strength measurements, throughout most of the predicted coverage area within the advertised range, were satisfactory. However, signal strengths north of Santa Barbara and east of Rancho Cucamonga, CA were inadequate, possibly due to signal masking from mountainous and/or forested terrain as the site is located near sea level. Additionally, a review of the output/reflected power and near-field signal strength levels was conducted and found to be satisfactory. All RTCM messages were verified and evaluated and are consistent with the requirements set forth by reference (3) and (4). Finally, accuracy measurements and analysis proved that at a distance of approximately 277 km from the broadcast site, the horizontal accuracy is less than 1.5 meters and within the accuracy requirements set forth by Reference (1) and (2).
