DIFFERENTIAL GPS (DGPS) SITE OPERATIONAL ASSESSMENT

NDGPS Site: Savannah DGPS Site (818)
Inspector(s): CWO3 Luisito Baytan, CWO2 Marin Kaczmar
Date: 08MAR13

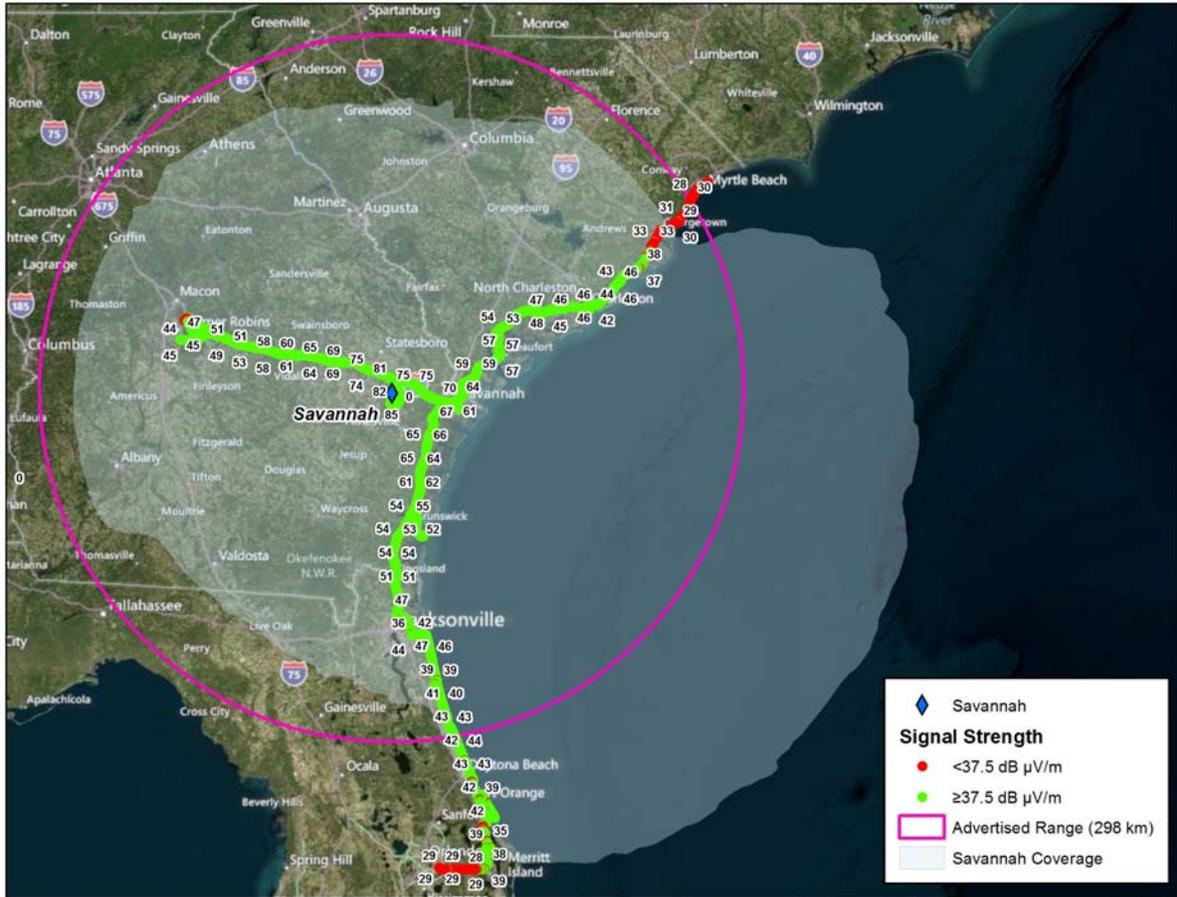
Figure 1: DNAV Signal Strength Results

A verification of the Savannah DGPS coverage area was conducted from Myrtle Beach, SC, along the coast to Savannah, GA; northwest to Macon GA along Hwy 16; through Savannah, GA, to Canaveral Groves, FL. The advertised signal strength range is 298 km. Figure 1 below displays inadequate signal strength in a small northeast coastal section of the coverage area with signal strength well above adequate throughout the rest and extending well south of predicted coverage area. Green points represent areas of satisfactory signal strength. Areas of

unsatisfactory signal strength are represented with red points. Far-field (FF) signal strength readings were taken at the northern and southern points of the advertised range from both transmitter sides of the site. Table 1 shows that the North FF reading was not within the required 37.5 dB μ V/m. OA team took multiple readings within the area with negative results. Table 2 shows that the South FF reading was well above the required signal strength of 37.5 dB μ V/m.

The Operational Assessment of the Savannah DGPS site revealed that the provided coverage is not consistent with the predicted coverage plot and advertised range. The Southern Far-Field Signal strength reading exceeded the predicted coverage area within the advertised range. The Northern Far-Field signal strength readings did not meet the required signal strength in the predicted coverage area within the advertised range. A review of the output/reflected power and near-field signal strength levels was conducted and found to be satisfactory. All RTCM messages were verified and evaluated and are consistent with the requirements set forth by reference (2) and (3). Finally, accuracy measurements and analysis proved that at a distance of approximately 123.4 km SE from the broadcast site, the horizontal accuracy is sub-meter and within the accuracy requirements set forth by Reference (1) and (2).
